## Technical tree inspection case study from Hazard Tree Conference, Sedona 2013: stem base, sonic tomogram and resistance drilling profiles

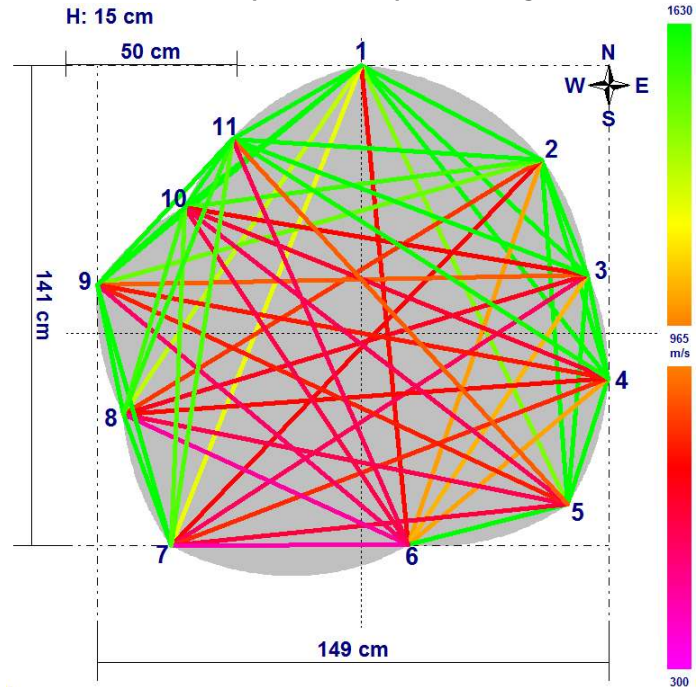
ARBOTOM® - sonic (stress wave) line tomogram:

The line graph just reveals the 'apparent speed': one sensor is tapped and then all other sensors measure the time of flight of the first arriving (=fastest) stress wave. When damages are present in the cross section, the fastest wave most likely made a detour around the damaged area. Thus especially the red and purple lines commonly do not represent the travel path of the measured stress wave.

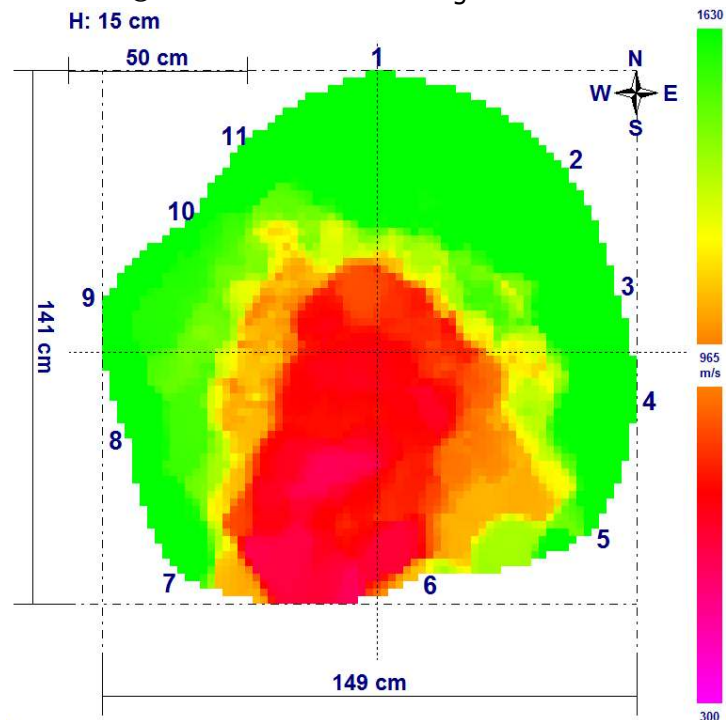
ARBOTOM® - sonic stress wave tomogram:

Based on this line graph, the measured values, and the typical mechanical properties of the wood species, the computer program calculates the most probable distribution of intact wood in the cross section (green) and creates the 'tomogram'. But there is no information about what is going on in the red and/or purple area because there are no values coming from such areas, thus no spatial resolution can be defined! The red/purple parts just do not contribute to the load carrying capacity of the cross section, what is usually more important than wood condition in terms of safety evaluation.

Although a significant part of the cross section is damaged (decay and/or void), the load carrying capacity ('stability') of this cross section (as described and represented by the section modulus) is reduced by only about 25% - compared to the fully intact cross section. Such a reduction is similar to the situation of a circular trunk cross section with a hollowness of approximately 70%. That means, in terms of stability, the reduction found here is similar to a tree with  $t/R \sim 1/3$ . But, the tree inspected here, has already reached it's maximum height years ago and consequently the basic safety factor is much higher due to the continuous growth in girth. Because the load carrying capacity depends on the diameter to the power of three, even slight radial increments have a much bigger impact on stability. Consequently, the cross section shown here is correspondingly 'safer' than a circular stem being centrally deteriorated by about 70% and having  $t/R \sim 1/3$ . Thus, there is currently no need to prune or take down the tree because of this damage. But, the future situation can not be estimated based on the tomogram. Resistance drilling profiles help making better estimates for future developments because they indicate deterioration propagation trends:

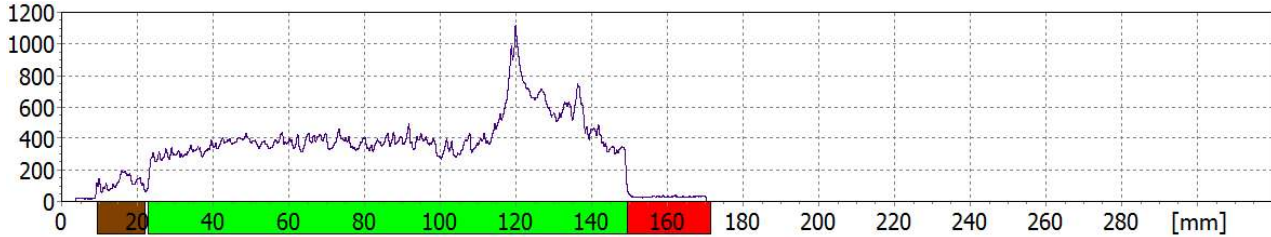
RESISTOGRAPH® - profile approx. 1m (~3ft) above sensor 8 (300mm ~ 1ft). A steep drop of the profile from intact to decay indicates that deterioration stopped propagating in this area. A peak mostly comes from a densified compartmentalization zone (additional subberines+phenols+ ... in the cell lumen):

The drilling above sensor 8 was too high to be directly compared with the tomogram:

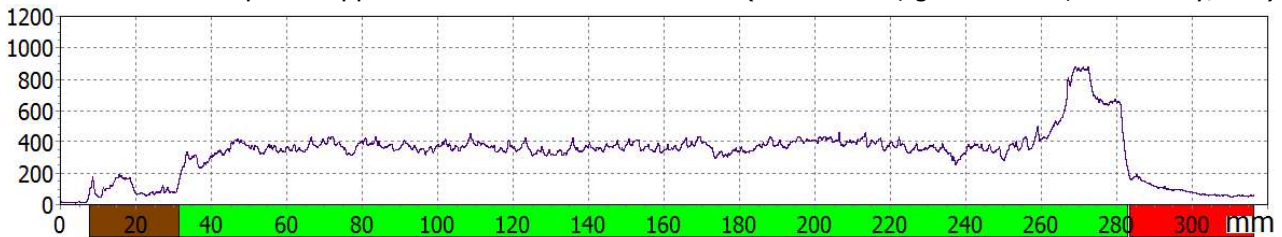
RESISTOGRAPH® - profile approx. at sensor 2: (brown=bark, green=intact, red=decay/void)

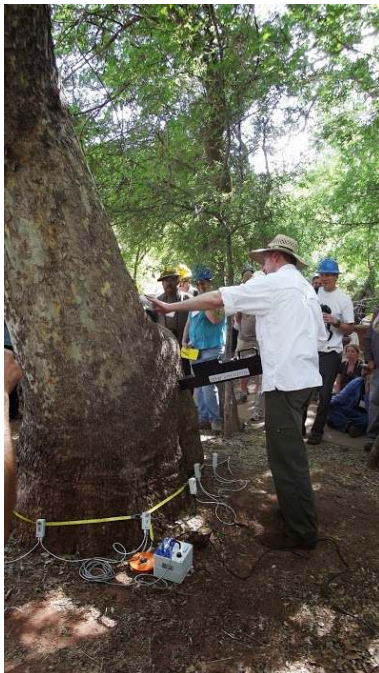
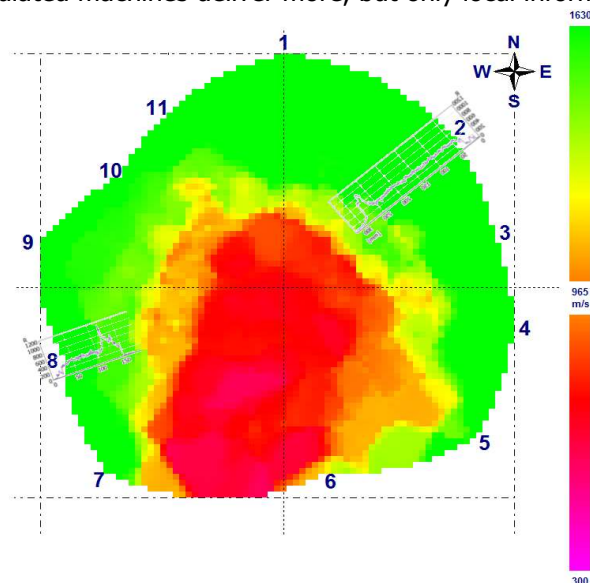
The superposition at sensor 2 shows that, in this case, the tomogram over-estimates the shell wall thickness: the inner side of the remaining intact wood was dry, leading to a unusual higher sonic speed (suggesting more sound wood than real). Resistance drilling profiles from calibrateable, electronically regulated machines deliver more, but only local information:

Based on these results I do not see any need for any urgent action. However, the assessment should be extended to other parts of the trunk and the roots before drawing final conclusions and giving recommendations. Visual inspection has to take special care about this tree in the future and determine when/if technical re-inspection is required.
