## Technical tree inspection case study from Hazard Tree Conference, Sedona 2013: stem base, sonic tomogram and resistance drilling profiles

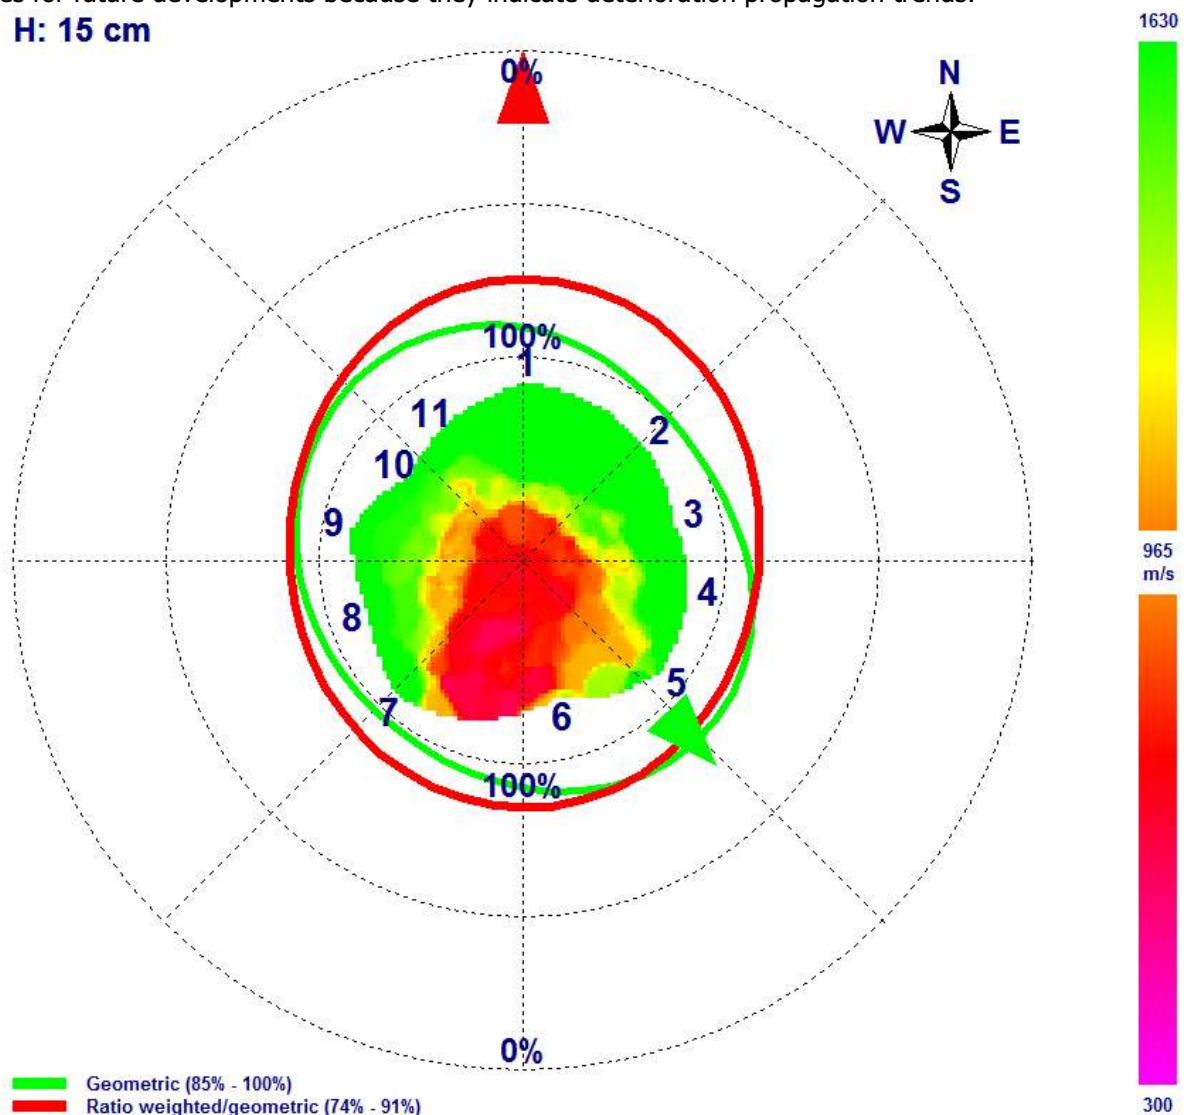
**H: 15 cm**

Although a significant part of the cross section is damaged (decay and/or void), the load carrying capacity ('stability') of this cross section (as described and represented by the section modulus) is reduced by only about 25% - compared to the fully intact cross section. Such a reduction is similar to the situation of a circular trunk cross section with a hollowness of approximately 70%. That means, in terms of stability, the reduction found here is similar to a tree with  $t/R \sim 1/3$ . But, the tree inspected here, has already reached it's maximum height years ago and consequently the basic safety factor is much higher due to the continuous growth in girth. Because the load carrying capacity depends on the diameter to the power of three, even slight radial increments have a much bigger impact on stability. Consequently, the cross section shown here is correspondingly 'safer' than a circular stem being centrally deteriorated by about 70% and having  $t/R \sim 1/3$ . Thus, there is currently no need to prune or take down the tree because of this damage. But, the future situation can not be estimated based on the tomogram. Resistance drilling profiles help making better estimates for future developments because they indicate deterioration propagation trends:

Based on these results I do not see any need for any urgent action. However, the assessment should be extended to other parts of the trunk and the roots before drawing final conclusions and giving recommendations. Visual inspection has to take special care about this tree in the future and determine when/if technical re-inspection is required.
